# Airfield Research Group Ltd

## ARG Research Note No.27: RAF Alconbury - A Record Survey of the Hush House and Control Tower

Paul Francis and Paul Bellamy – July 2015

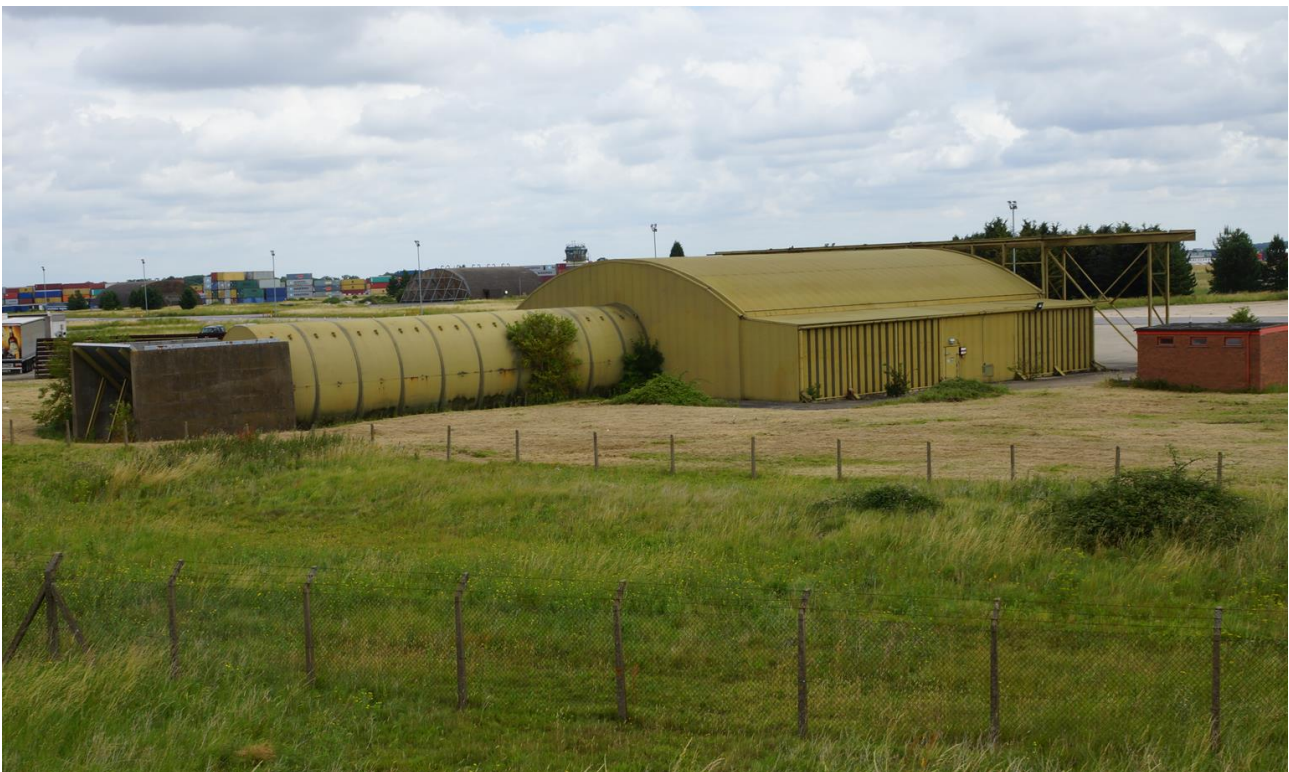
Plate 3: A distant view of the hush house looking north showing the detuner and exhaust deflector, the east annexe with 3-bay noise suppressor, 2-bay inlet section and the main hangar with its projecting door gantry (Blg.68)

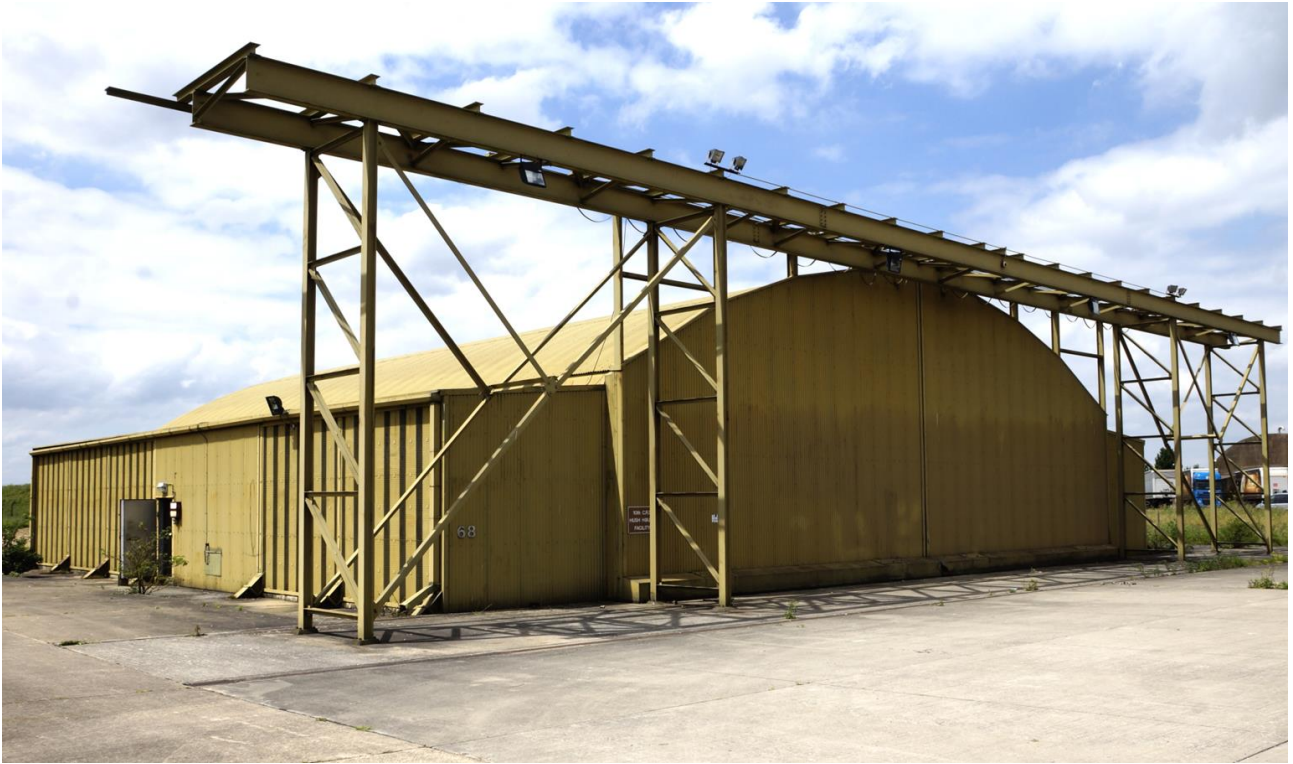
Plate 4: Hush house front and side view (Blg.68)

The structure consists of a 6-bay all-steel blister-shaped hangar-like building with a large door gantry running along and projecting out from the front elevation. Electrically operated main doors are in two leaves and run on rails, the chain-driven motors being located within a compartment at the bottom of the doors. The substantial lattice girder of the door gantry appears to be over engineered but is designed to resist the vacuum caused by an operating gas turbine engine. The rear of the hush house has a long projecting 13ft diameter detuner which is 79ft 6in long and this terminates at a concrete and steel exhaust deflector (8ft 9in by 21ft 2in). This is accessed from inside the building by roller shutters. Interior cladding is of metal perforated and insulated acoustic panels and the exterior is painted corrugated sheeting.

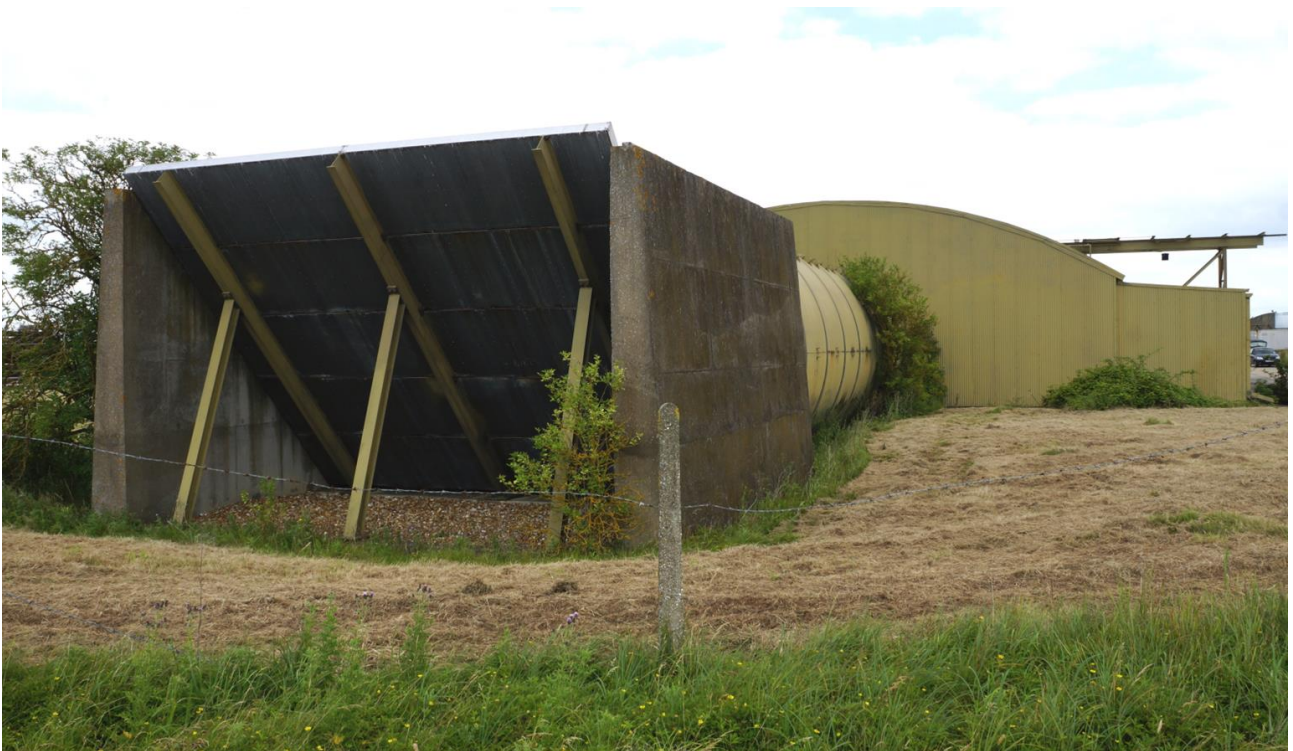
Plate 5: Rear view showing the exhaust deflector (Blg.68)

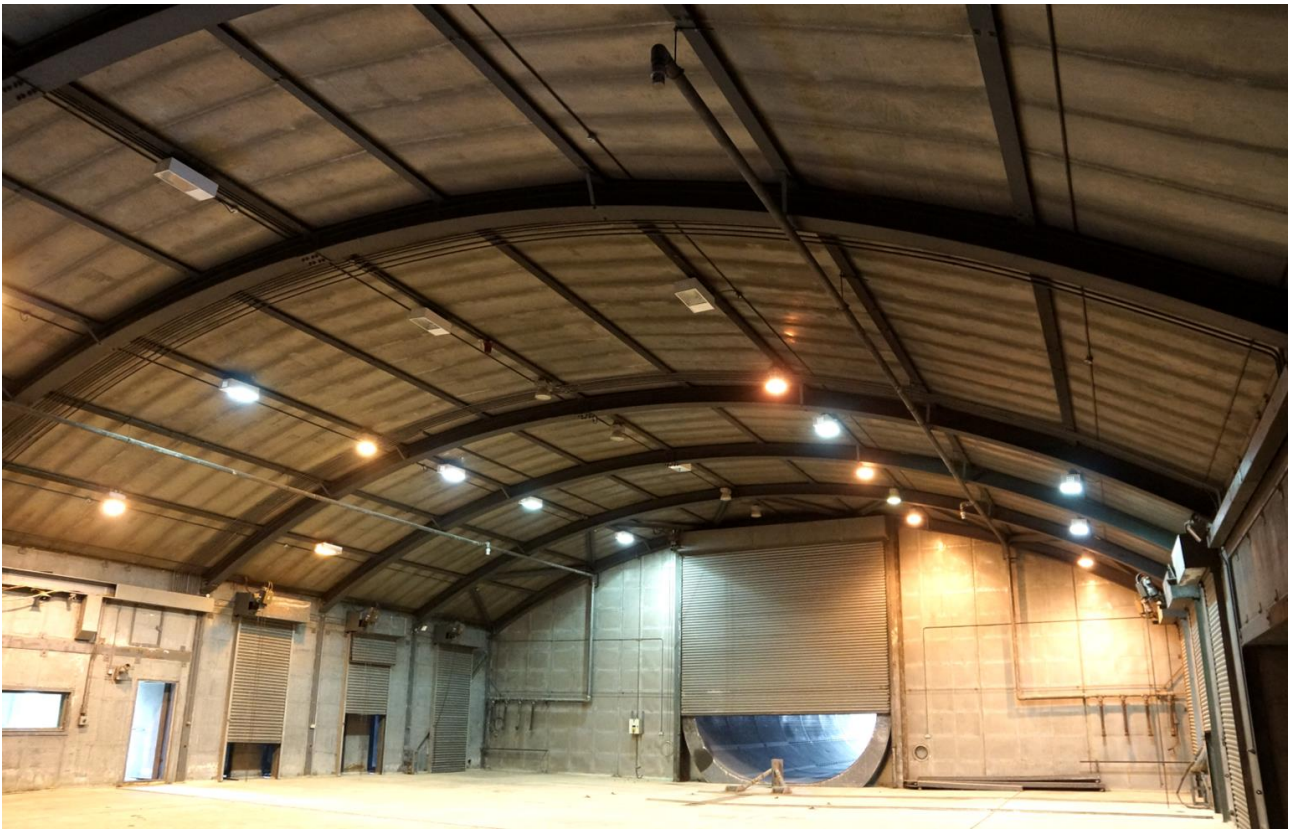
Plate 6: Interior view looking towards the detuner (Blg.68)

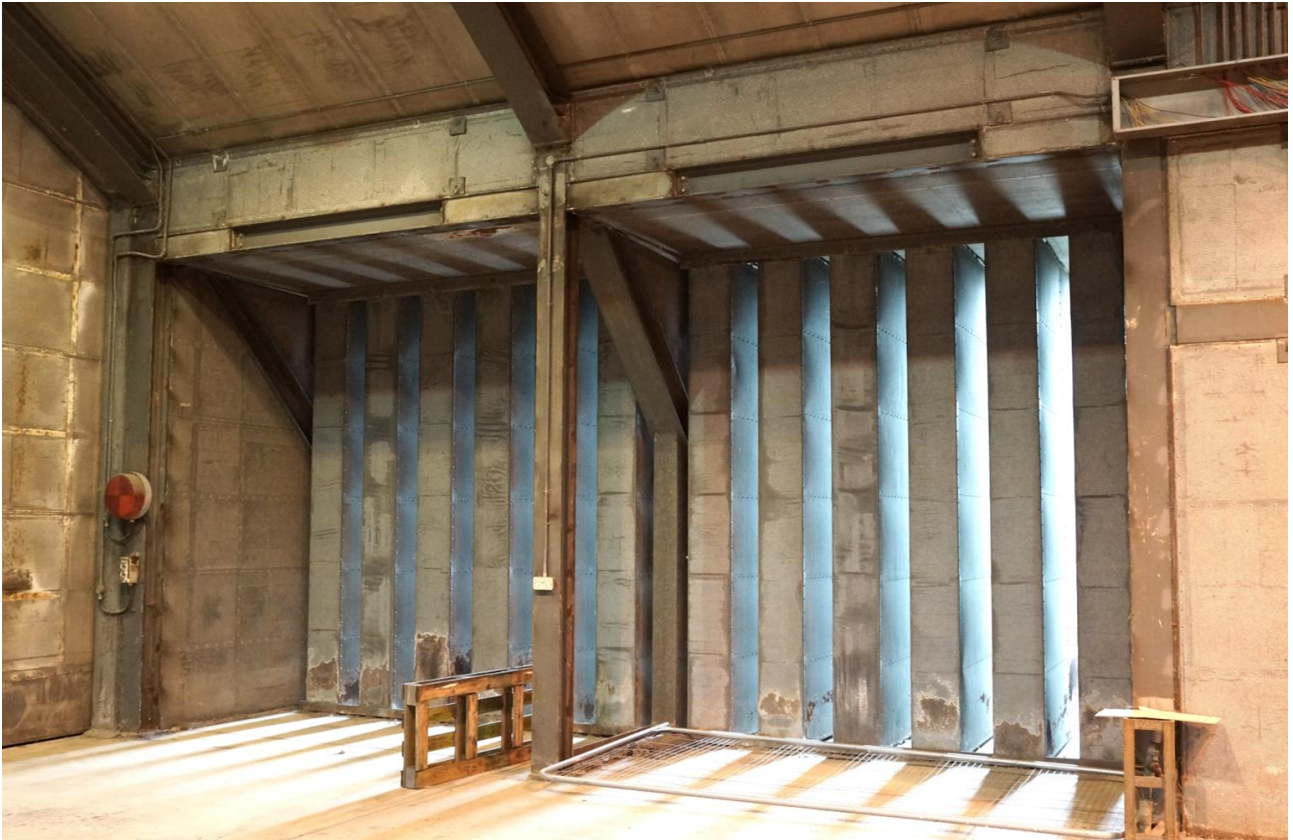
Plate 7: Air inlet straighteners inside the east annexe (Blg.68)

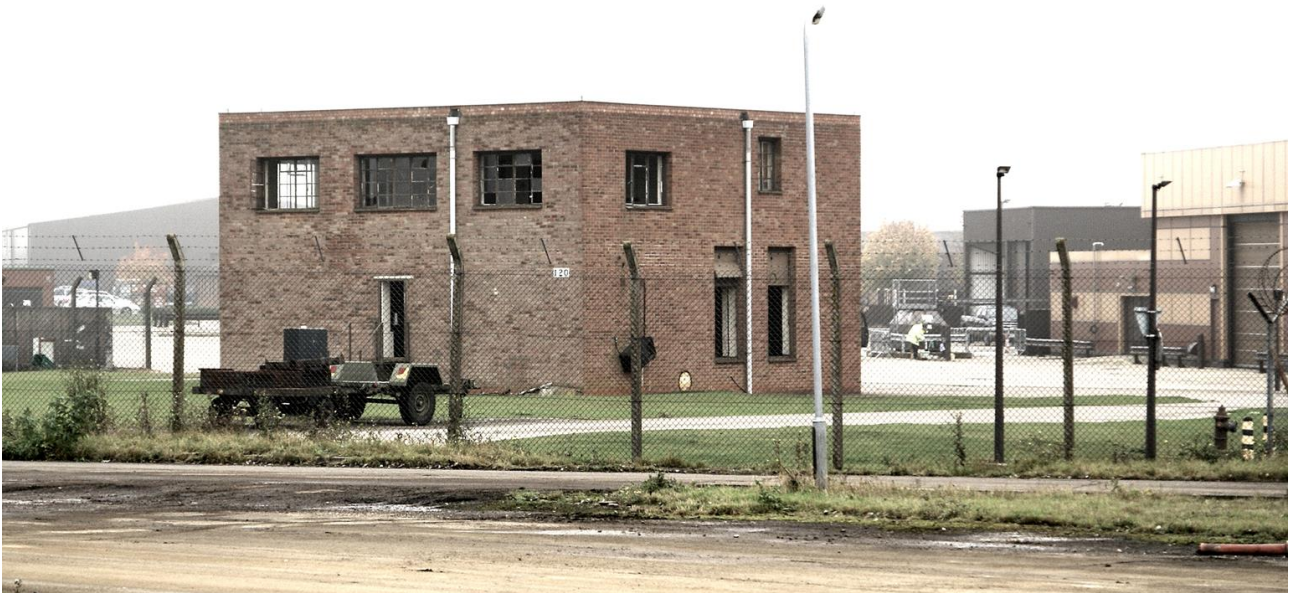
Plate 12: The much altered third watch office building, as seen in 2012. Note that despite its external appearance, inside the rooms looked just as they did during WWII.

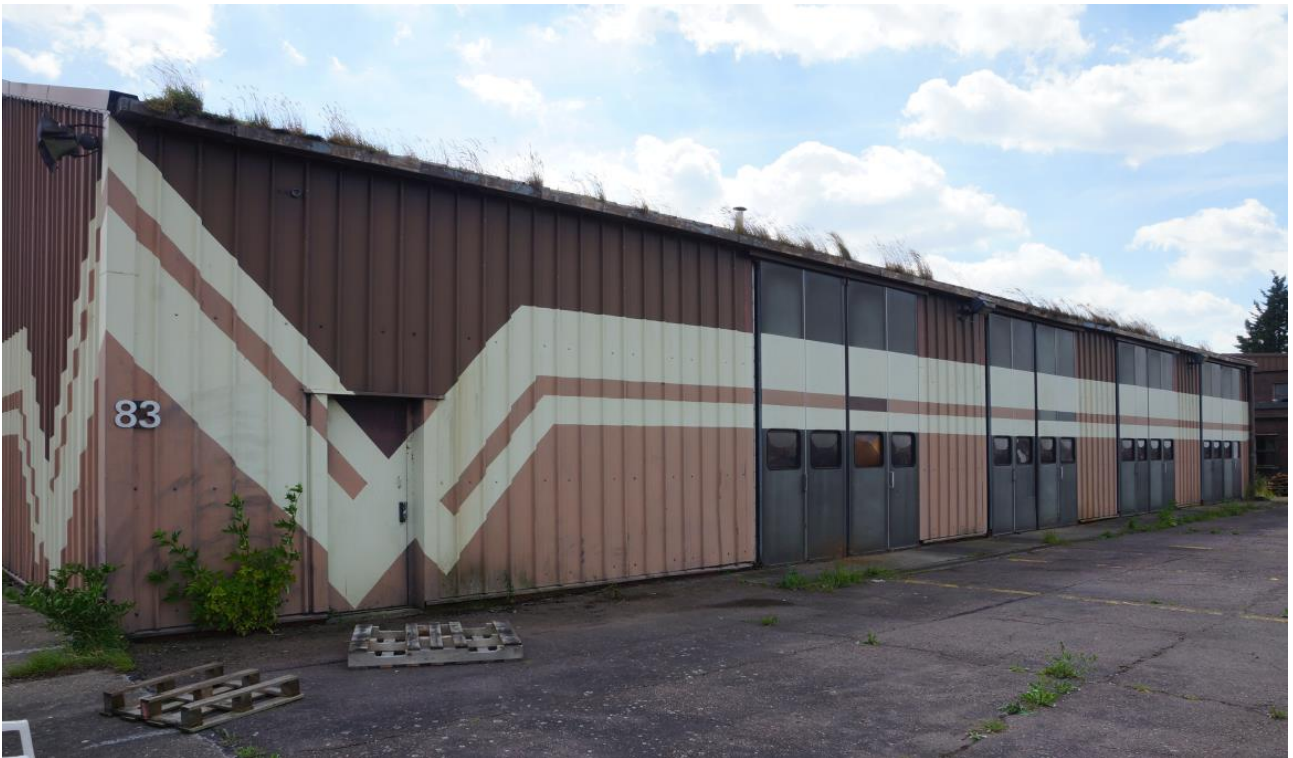
Plate 14: front elevation (Blg.83)

It consists of a steel rigid portal frame made of tapered plate steel stanchions and tapering roof beams at 20ft centres. This version of c.1956 is a side opening shed, originally having sets of full height doors, one per bay and this elevation faces north onto a paved area. Before 1986 an internal perimeter wall was built of concrete block and a pair of bays was separated from the others by a concrete block wall. The main doors of these two bays were removed and blocked up and the others were removed and replaced. After 1986, the original exterior cladding was removed and replaced with Robertson's Trisomat composite panels. Also removed were louvred panels and a pair of windows on the end elevations.

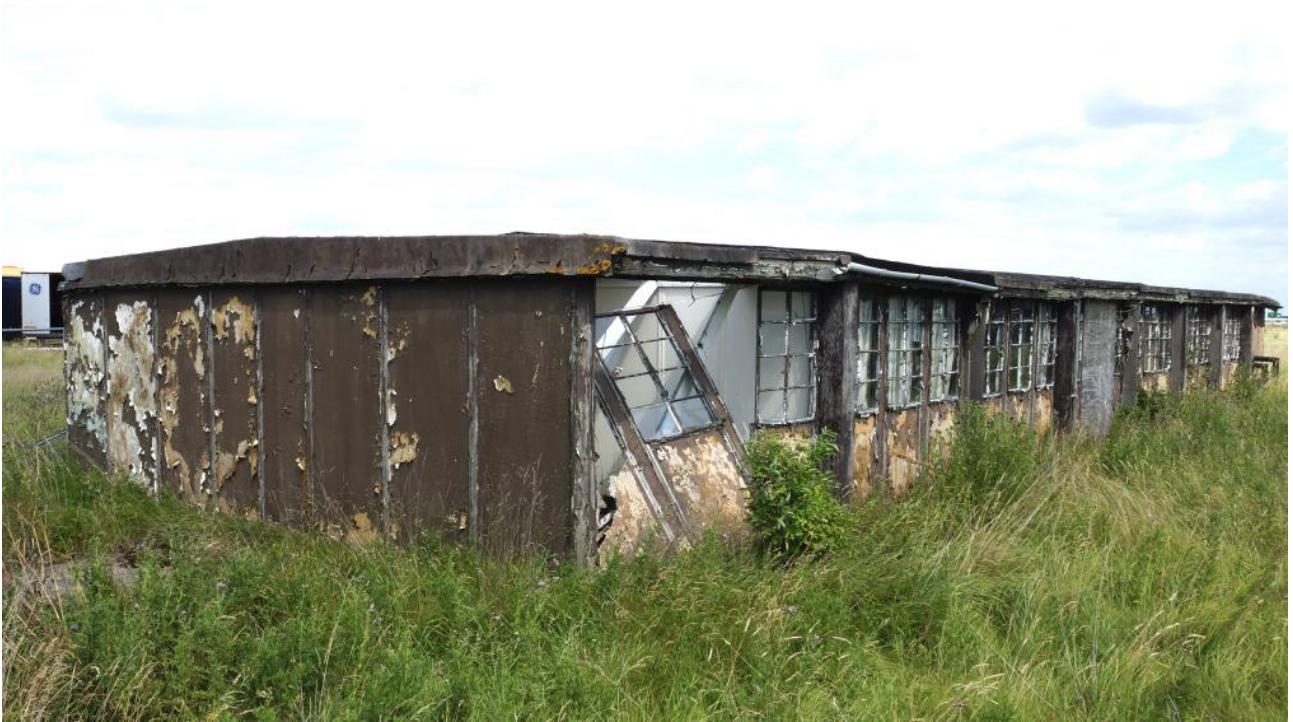
Plate 17: Base Operations, a view looking east (Blg.86)

Uni-Seco buildings consist of a series of standardised columns, beams and panels assembled into a grid pattern of 4ft by 3ft 6in units. The principle materials are timber / plywood, asbestos cement sheeting and wood-wool. Timber columns are erected at 12ft centres and these are connected in opposite pairs by timber and asbestos cement roof beams, sloped above to give provide a series of low pitch trusses. These are connected by secondary spars carrying slabs covered by roofing felt. Roof and wall panels consist of light frames of softwood covered on both sides with asbestos cement sheets and the void is filled with wood wool. Windows are multi-pane galvanised steel casements (normally six per bay), while end walls are blind.

The external walls of the teleprint and weather office rooms have collapsed, but the rest of the building is extant. The room arrangement is piratically as-built apart from a cupboard being converted into a lady's toilet. The original external paint scheme was white.

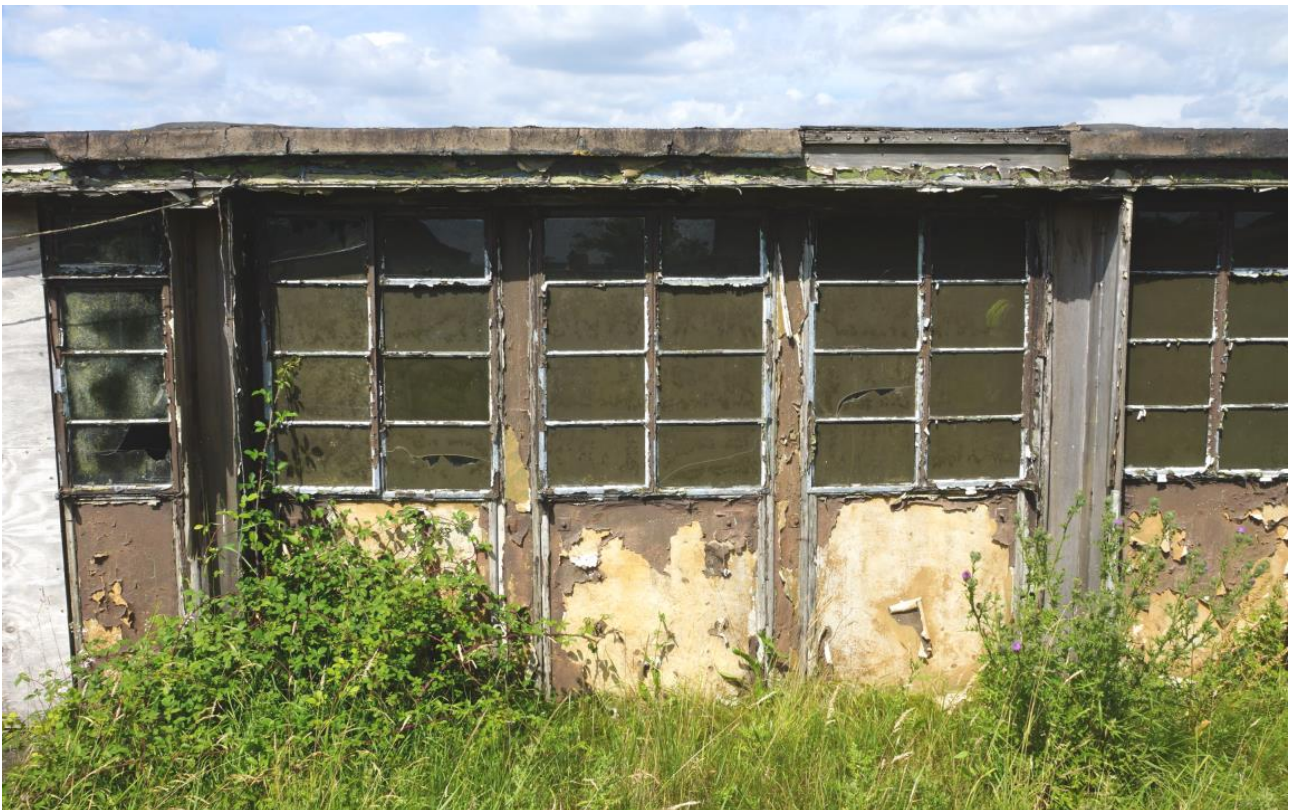
Plate 18: Window detail (Blg.86)

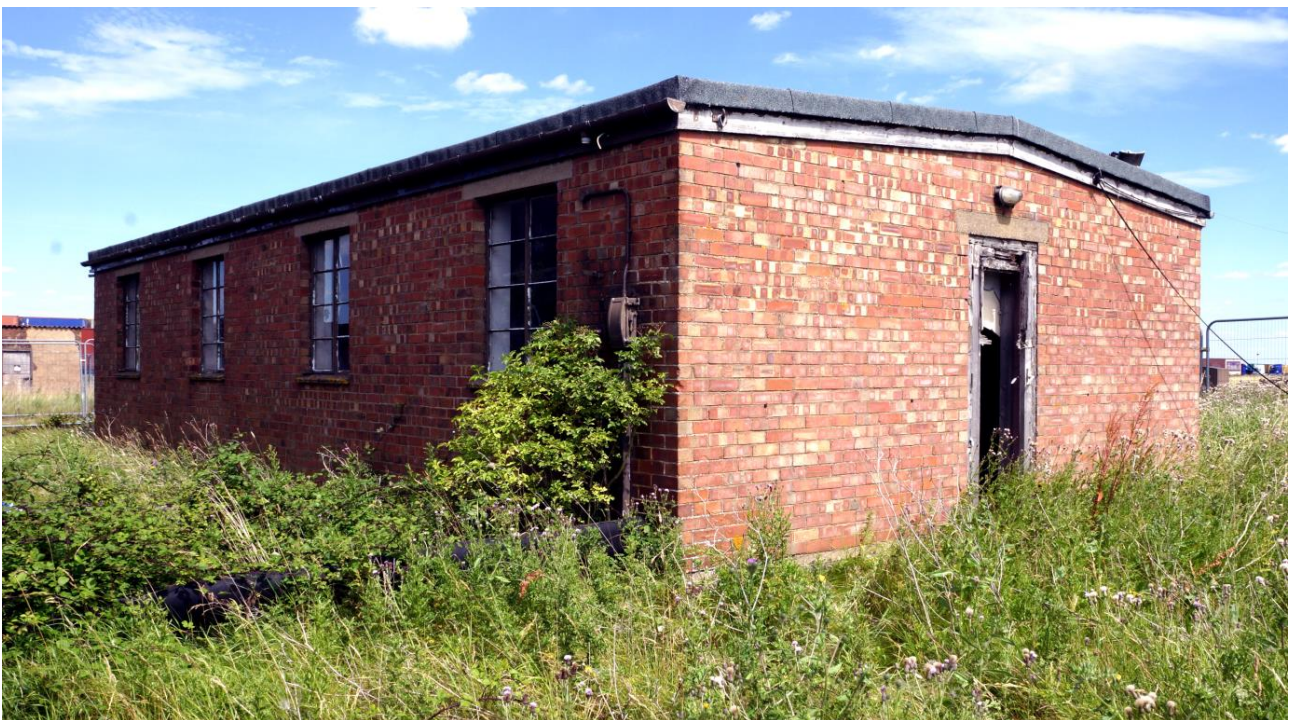
Plate 24: Administration offices (Blg.85)

It is constructed of 11in cavity brick with steel multi-pane windows. External doors are located in the end elevations. The roof is probably of timber construction with a shallow pitch, boarded and felted.

The original building measures 18ft 8in by 35ft 6in internally and the extension is 11ft by 11ft 8in.

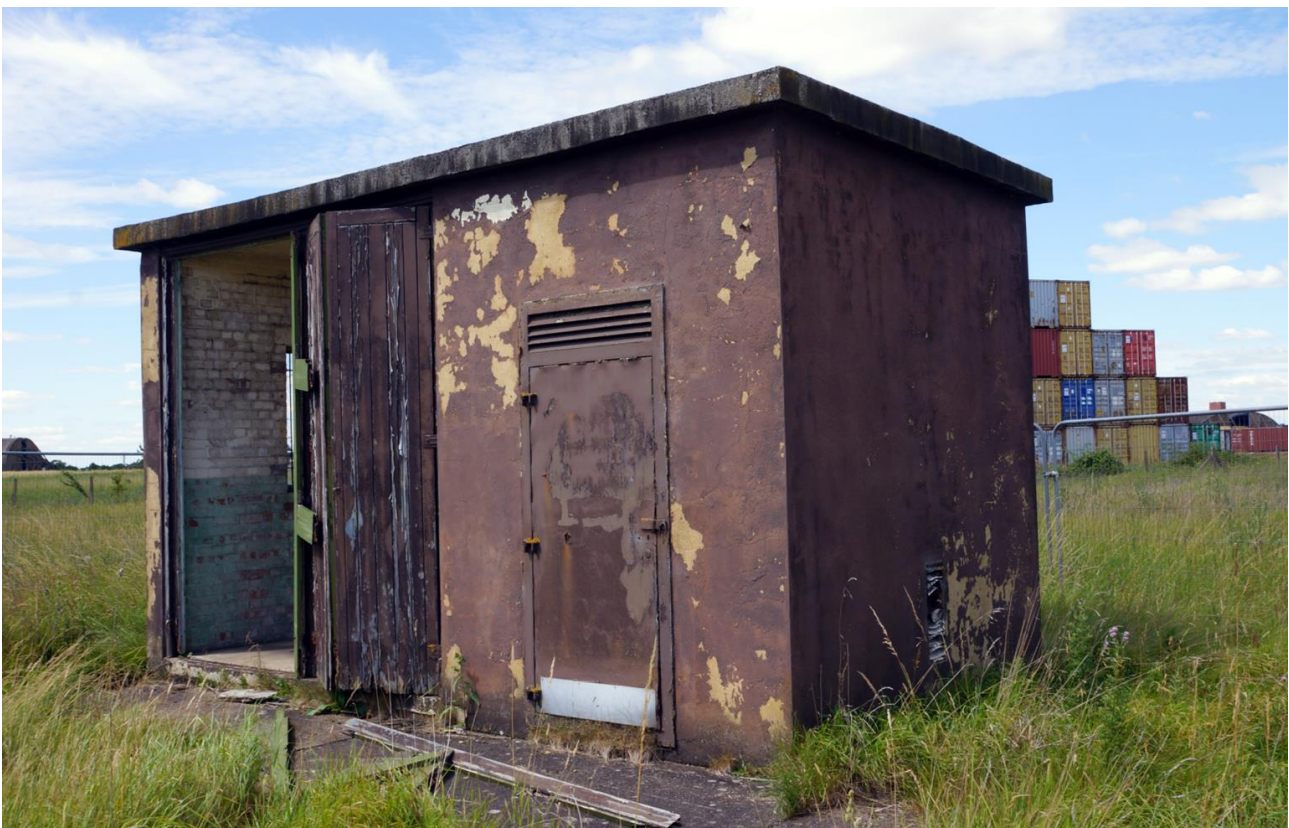
Plate 25: Balloon filling hut (Blg.87)

Both doors are on the east wall, the filling room having full width and height Esavian type 1032 folding timber doors, while the store has a vented steel frame and door supplied by AH Allen of Northampton, a steel stockholder still trading in the town.

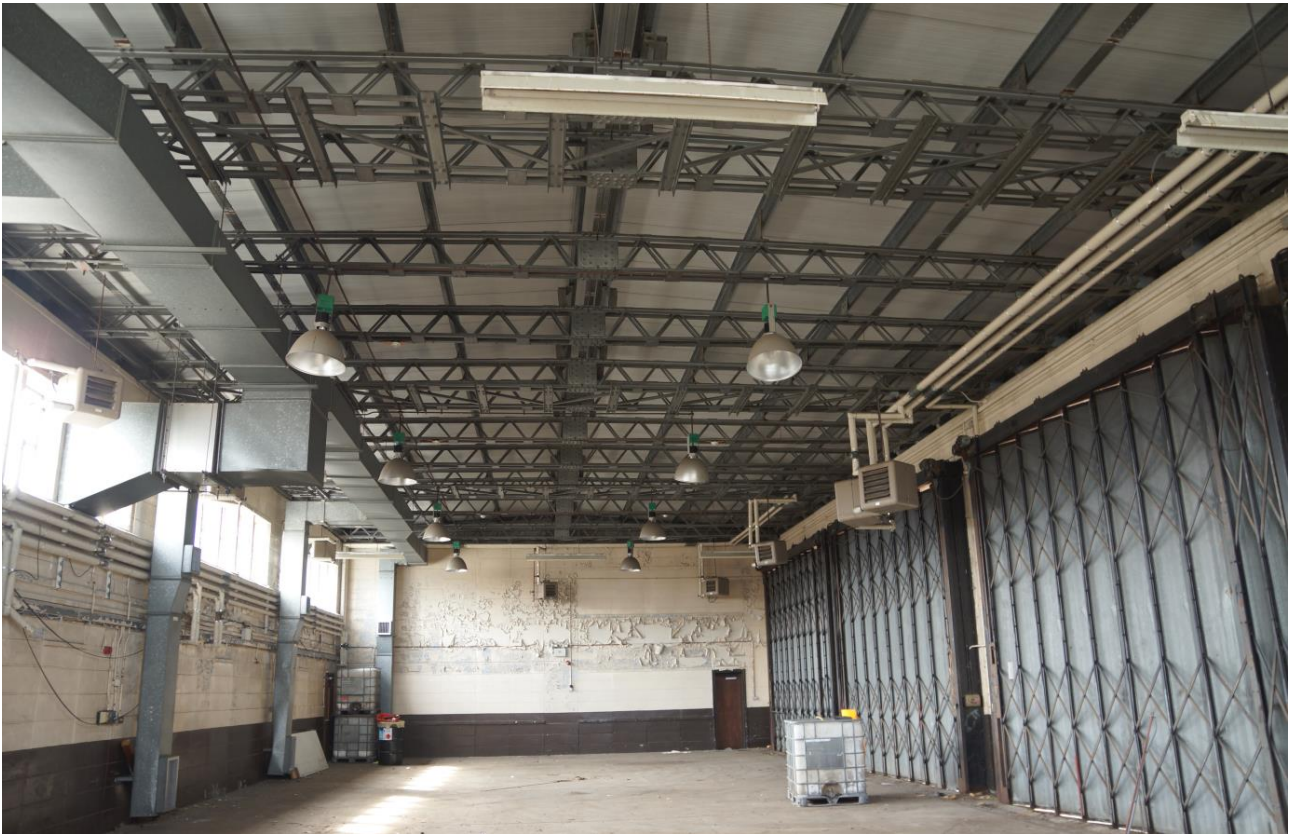
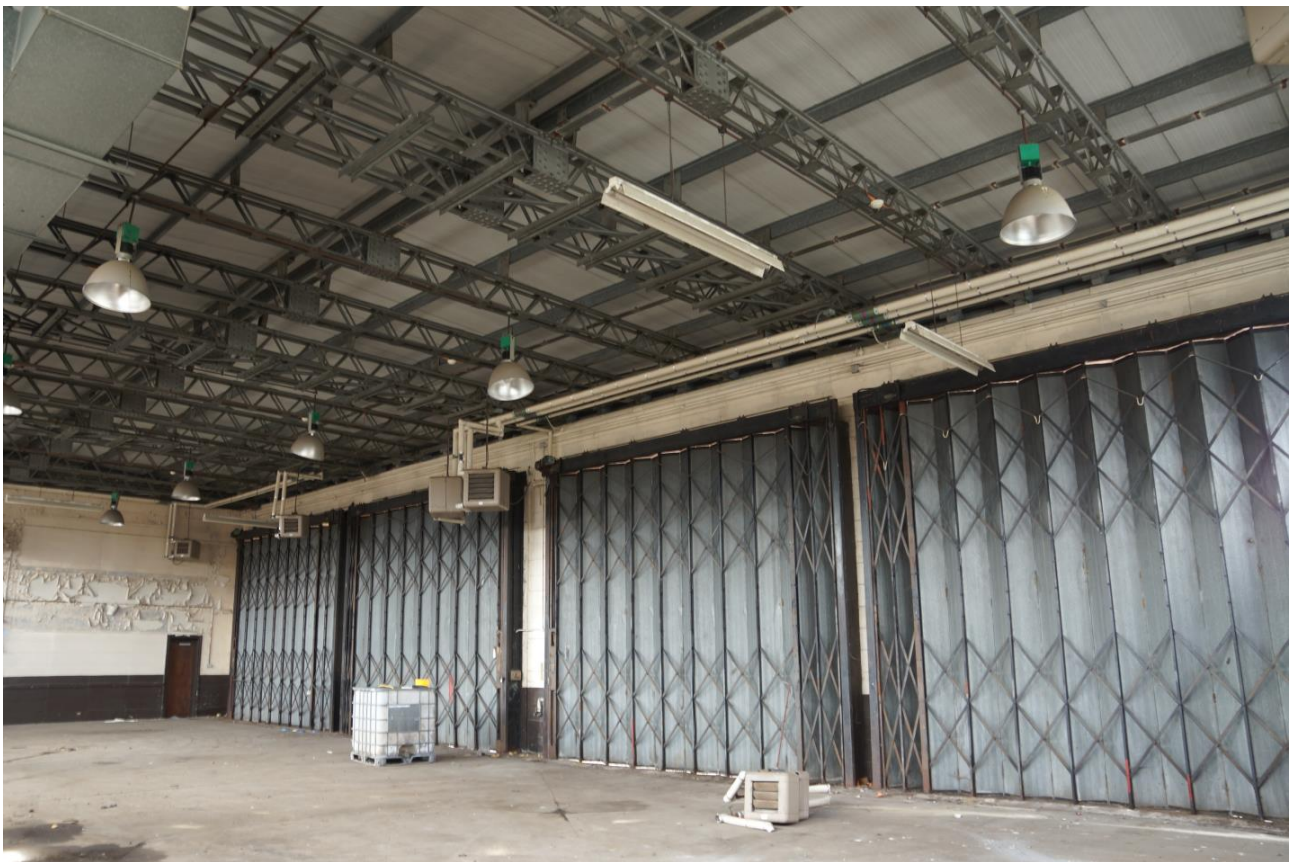
The roof consists of exposed double steel lattice angle-iron girders welded together by plates (Colvilles steel) over the taller parts and a pressed steel joist system (similar to that used in Unity houses) over the lower parts, it was originally clad with felted straw and timber roof slabs, but the appliance garage has been re-clad with Robertson's 'Trisomet' composite panel fixed to steel purlins.

Plates 35 & 36: Two interior views of the original garage, note the lattice girder trusses (Blg.88)

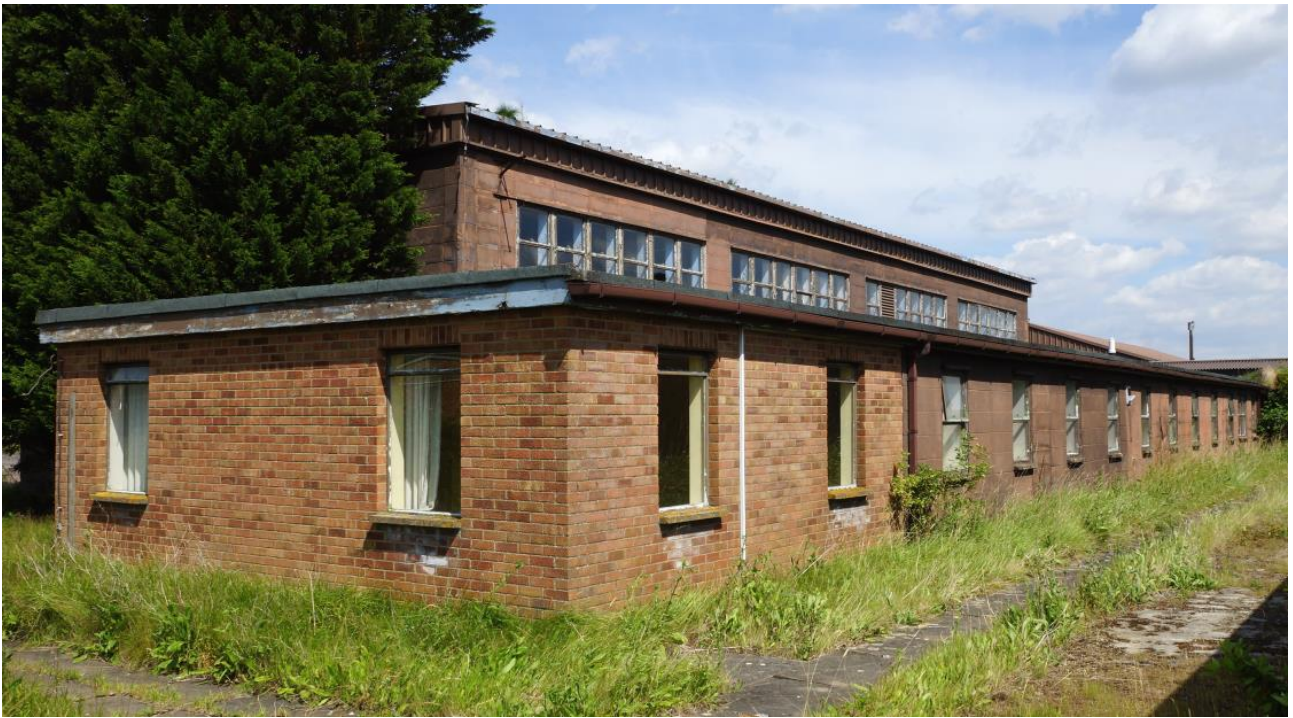
After 1977, a small single storey brick-built annexe was added to the rear annexe on the west elevation, this contained a pair of offices. A detached concrete walled enclosure was also built on the western side (opposite the dining hall) containing a 7-kw diesel emergency generator. In February 1986, the architect Raymond C Price under contract to the Property Services Agency, not only completely altered the interior layout of the annexes, he also designed a new fire crash station, built as a link-detached building to the south of the original one. The dormitory was completely stripped, doorways bricked up and partitions added to create new offices, a technical services room, toilets, stores and classrooms. A new N-S corridor running full width gave access to an exercise room, equipment room and an alarm room, while opposite these was a re-vamped dining room and kitchen. The old boiler room extension, along with the original chimney stack were each demolished and the original boiler room was adapted as a recreation room. The new N-S corridor left the old building to connect with the main entrance lobby of the new building.

Plate 37: Rear view of the original flight line fire station with office extension (Blg.88)

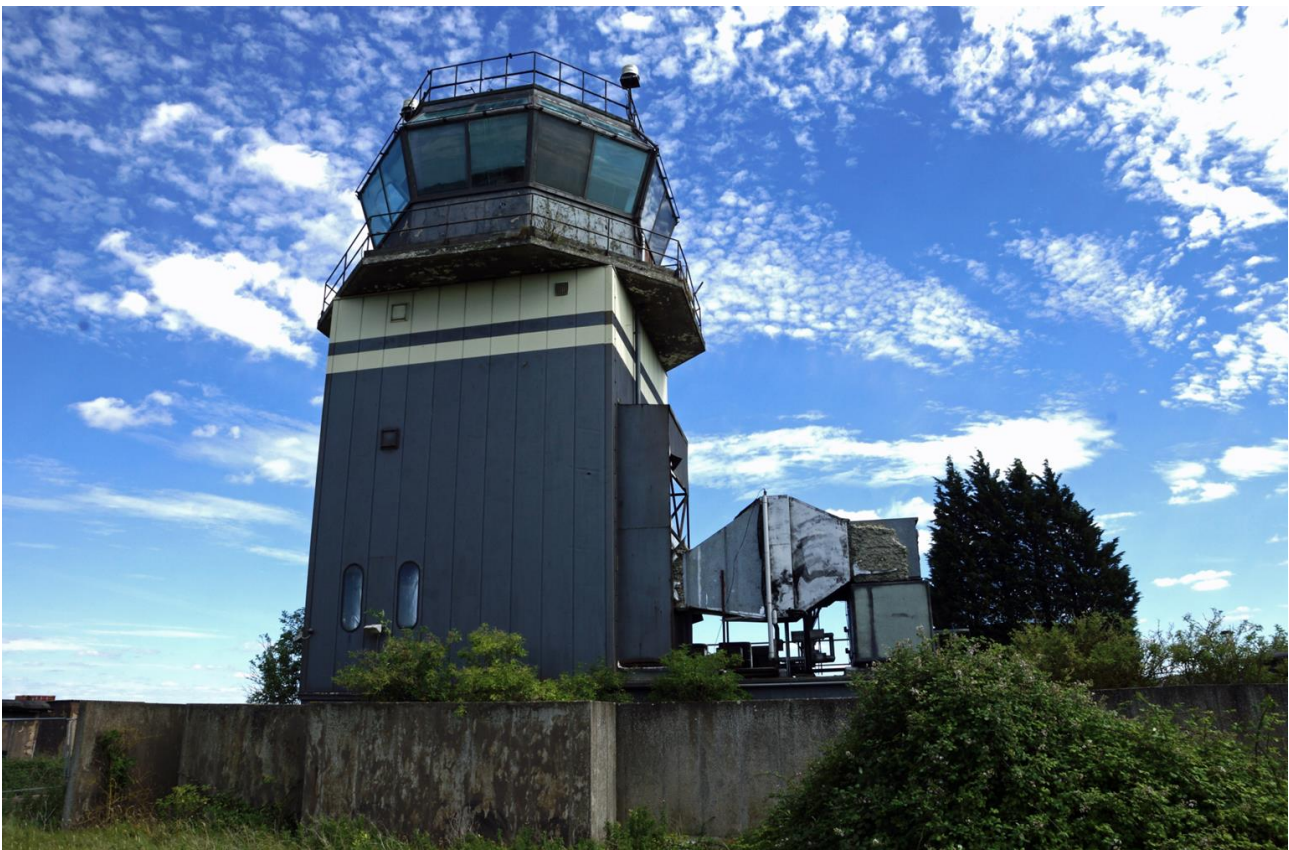
Plate 40: Control tower view looking east (Blg.90)

The building at Alconbury is aligned nominally N-S and faces the main instrument runway. It is part single but also rises to four storey height, the final storey being a cabin or visual control room. The tower is steel-framed, constructed of four primary stanchions of double RSJs (side to rear) and four intermediate RSJ stanchions of standard form. Horizontal RSJs support the light weight concrete slab floors. The stanchions were originally exposed internally but were later encased in asbestos sheeting. The as-built exterior cladding was Uni-Seco panels painted white fixed to battens with large steel windows. One large Uni-Seco panel on the south side of each floor was removable for installing equipment into the tower via a swivel hoist (which is also missing).

All external Uni-Seco panels were removed from around the tower, as were all metal window frames, the small third floor balcony was also removed. In place of the Uni-Seco units and windows are full height 'Luxalon'<sup>2</sup> type 605 sandwich panels which were fitted to angle irons at each floor level and the panels were painted a 'Laural' colour scheme. Window portholes were fitted at first floor only, the second and third floors being blind. A total of 13 glazed panels of the control cabin were also replaced at this time.

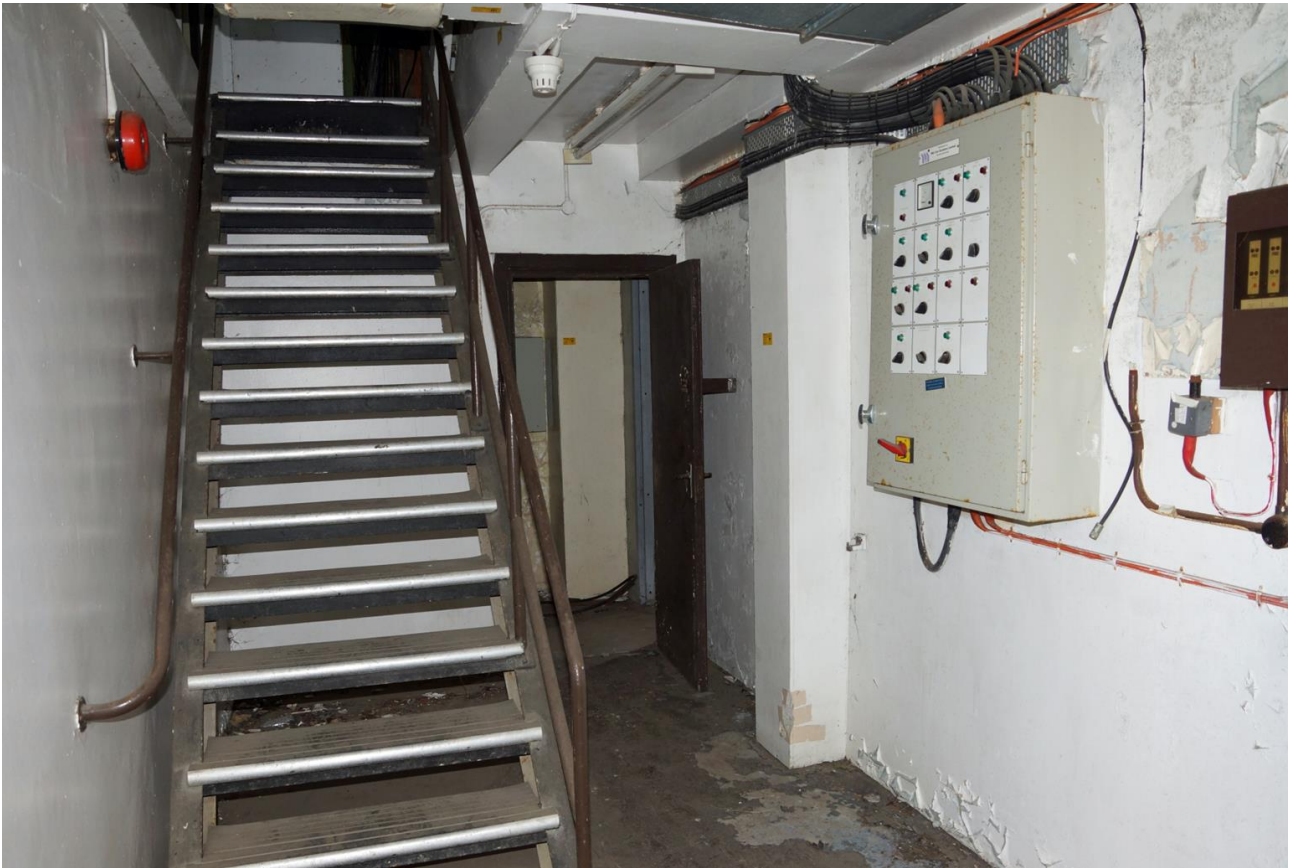
Plate 44: Entrance lobby and stair. Aircon control panel on the right-hand wall (Blg.90)

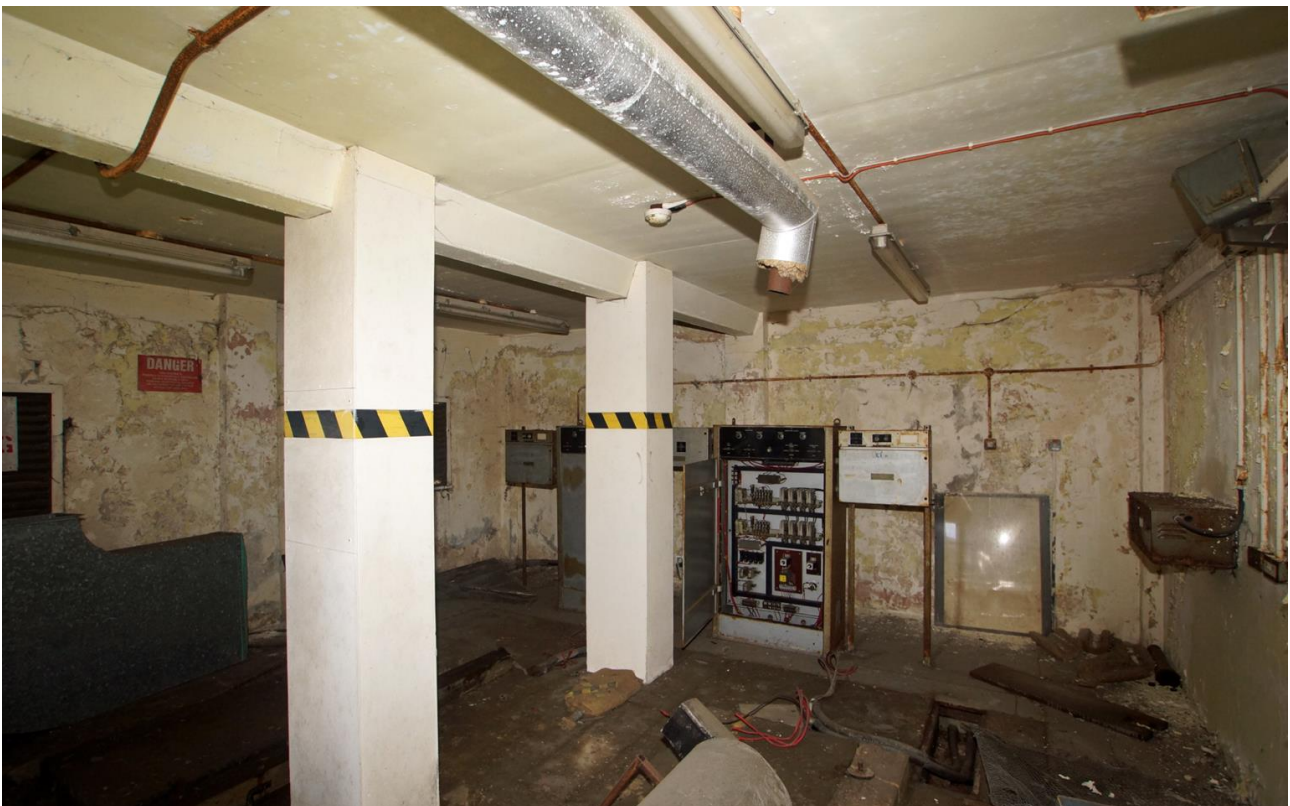
Plate 45: Generator room – view looking towards the control panels (Blg.90)

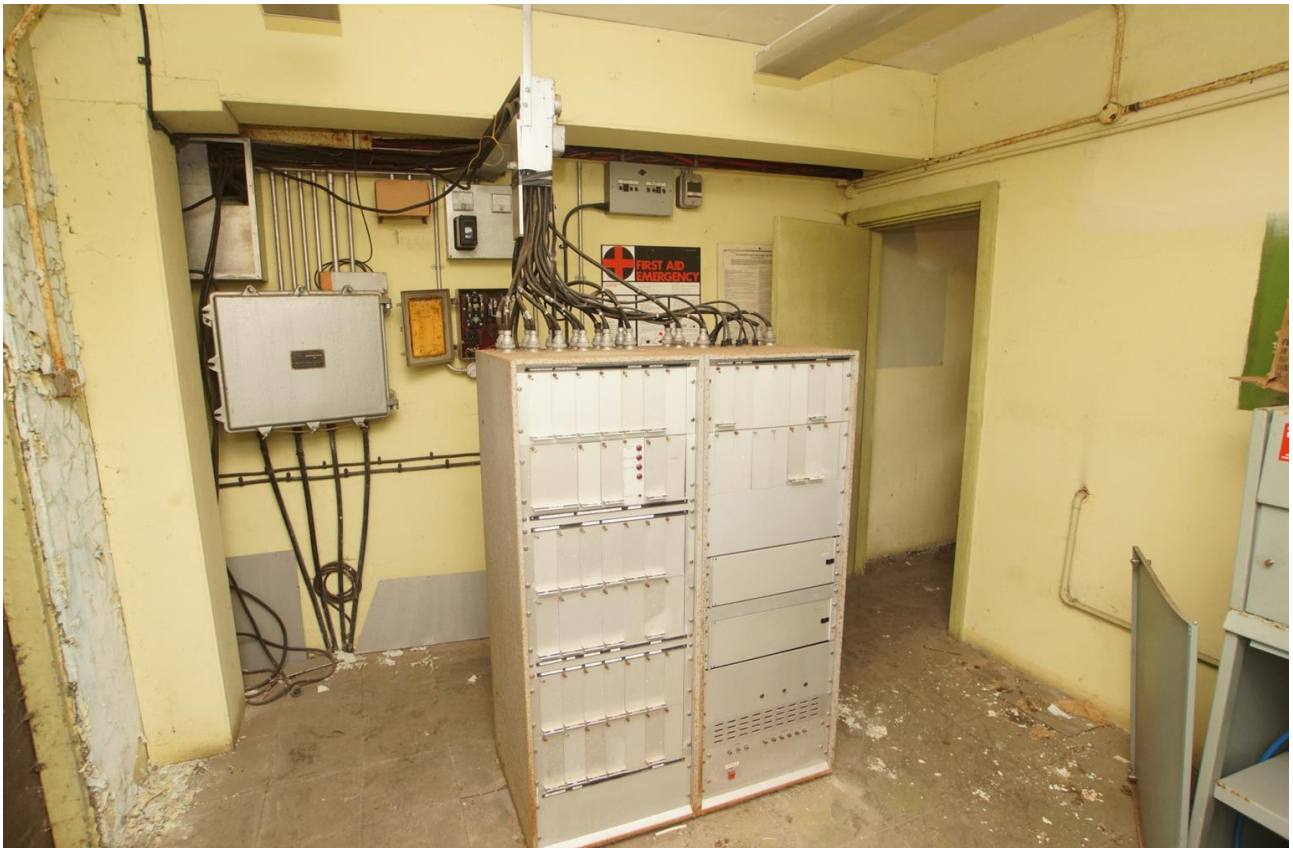
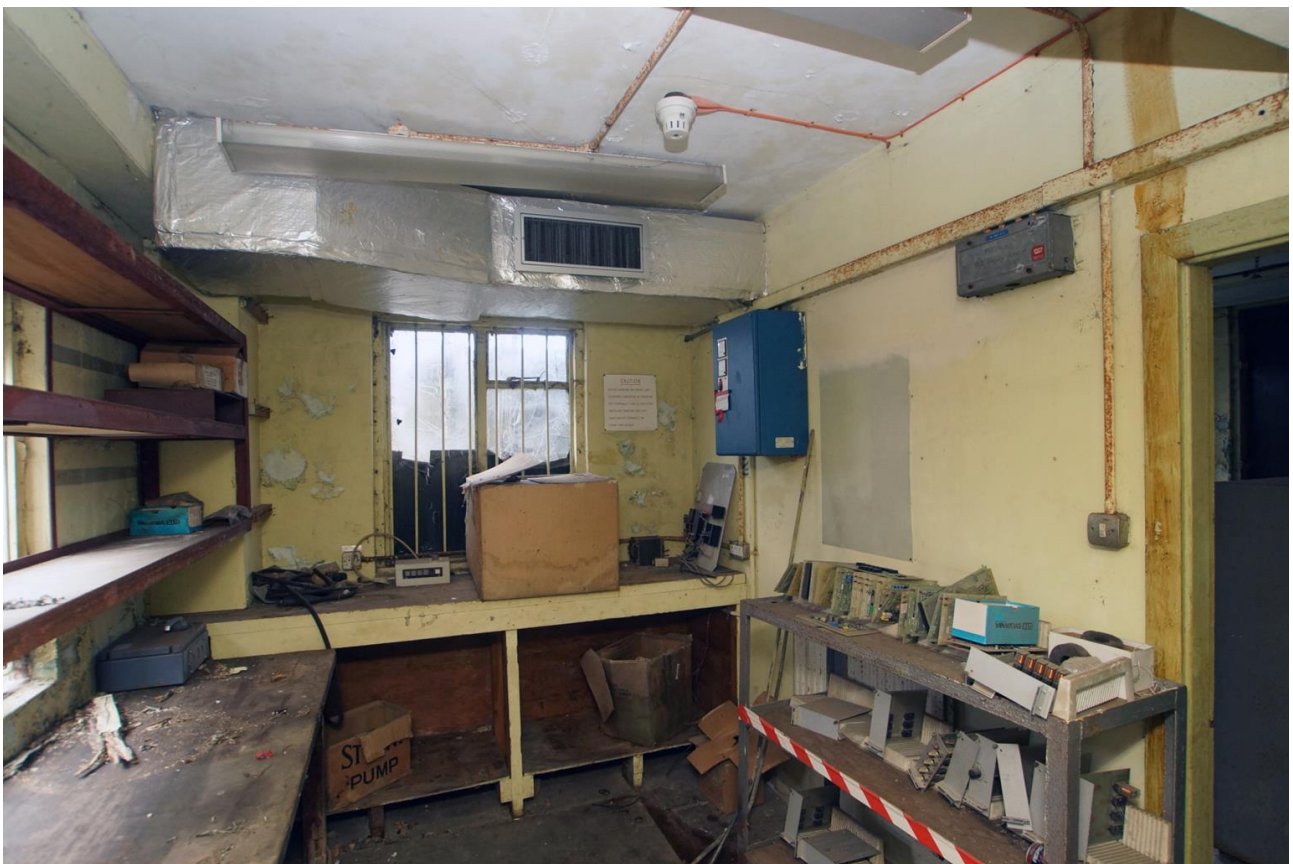
Plates 46 & 47: 'A' Centre with control panel and Battery charging room (Blg.90)
